— USS GETTYSBURG (CG-64) —
SEMAT I SHELL CONDITION ASSESSMENT
SURVEY
INTERIOR AREAS
12/03/01 TO 12/14/01

PREPARED BY
SUPERVISOR OF SHIPBUILDING CONVERSION
AND
REPAIR USN
PORTSMOUTH, VIRGINIA
12/14/01

SHELL CONDITION ASSESSMENT SURVEY INTERIOR AREAS TABLE OF CONTENTS

USS GETTYSBURG (CG-64)
SHELL CONDITION ASSESSMENT OF SURVEY SUMMARY, INTERIOR AREAS

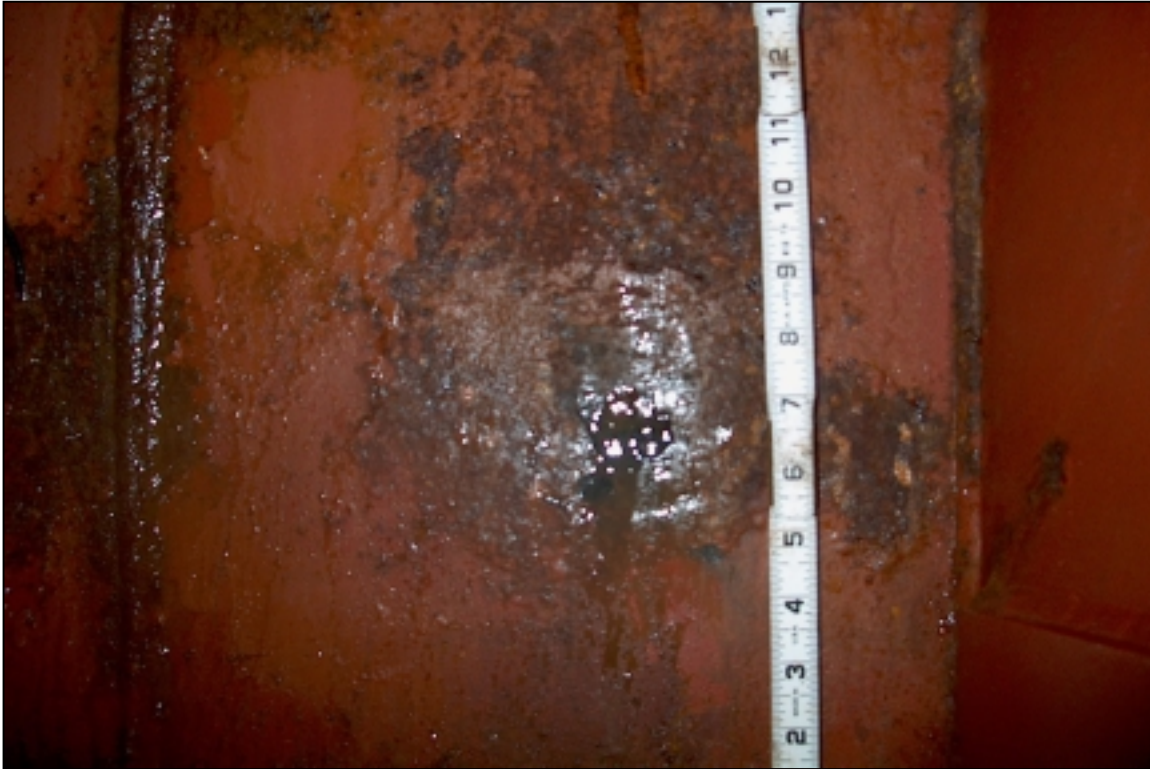
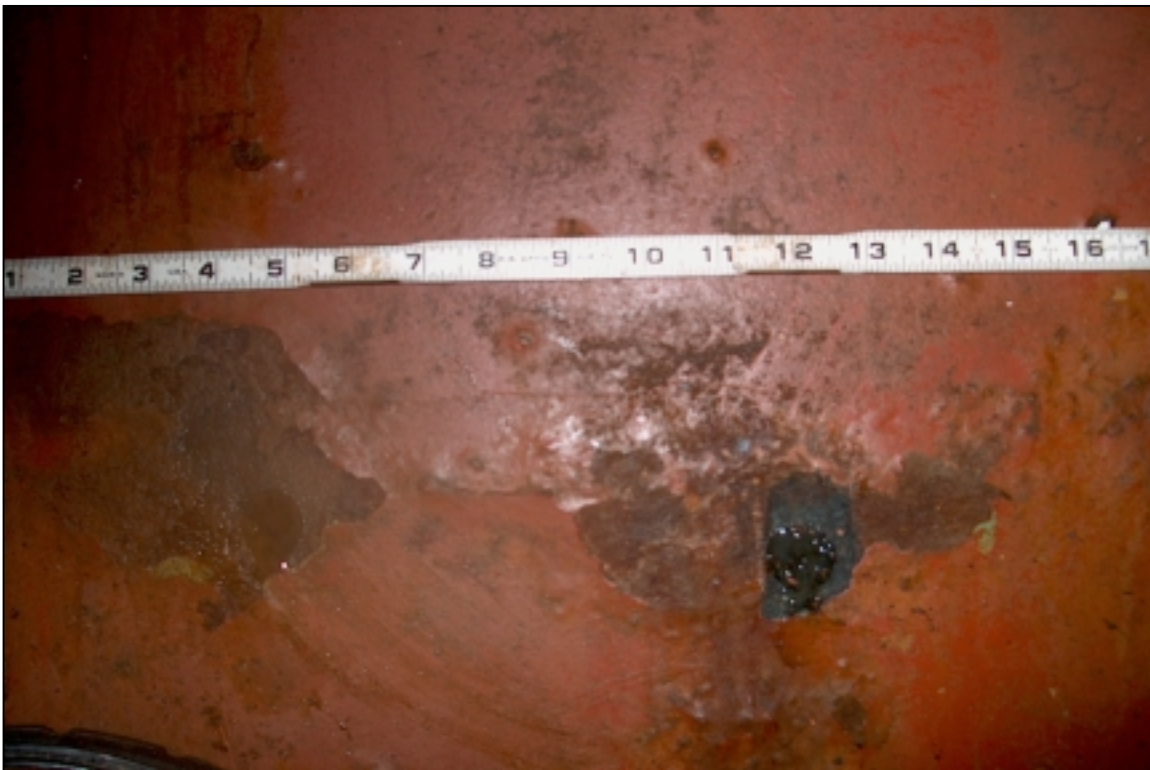
USS GETTYSBURG (CG 64)
MAIN ENGINE ROOM NO. 2
(5-300-0-E)

DISCREPANCY DESCRIPTION: PER SEMAT I UNDERWATER HULL ASSESSMENT: IN COMPT (5-300-0-E) THE LOWER FWD STBD CORNER FRAMES 300 – 308 HAS PITTING ON THE SHELL PLATING EG. 0.363, 0.356 AND COATING SYSTEM BREAKDOWN.					
RECOMMENDED REPAIRS: POWER TOOL CLEAN THE AREA FROM THE 2 ND TO THE 4 TH STRINGER DOWN FROM DECK GRATING LEVEL, PRIME AND PAINT THE AREA AND FINISH COAT TERRA COTTA.					
SSPORT C221 POC: J. BRUCKNER (757) 396-4001 EXT 2130 , TPOC: F. LaROCK QED					
CSMP SUMMARY: AREA OF SCALE AND PITS.				TEST# MRC 1102/1	
ROOT CAUSE/AMPLIFICATION: H1				STEP# 1,2,3,4 & 5	
SYSTEM LEVEL IMPACT: NONE					
PART NO.	NOMEMCLATURE		QTY	NSN	COST
1					
2					
3					
4					
5					
6					
FIRST CONTACT KOLP	RATE HT1	SECOND CONTACT DANIELS		RATE HT2	PHONE
ASSESSOR / ACT / TECH ID# F. LaROCK/ A. WRIGHT QED SYSTEMS INC.			TD	TL	LOGISTICIAN
					TSP

AREA OF HEAVY SCALE AND RUST IN BILGE BETWEEN FRAME 300 – 308 ON STBD SIDE

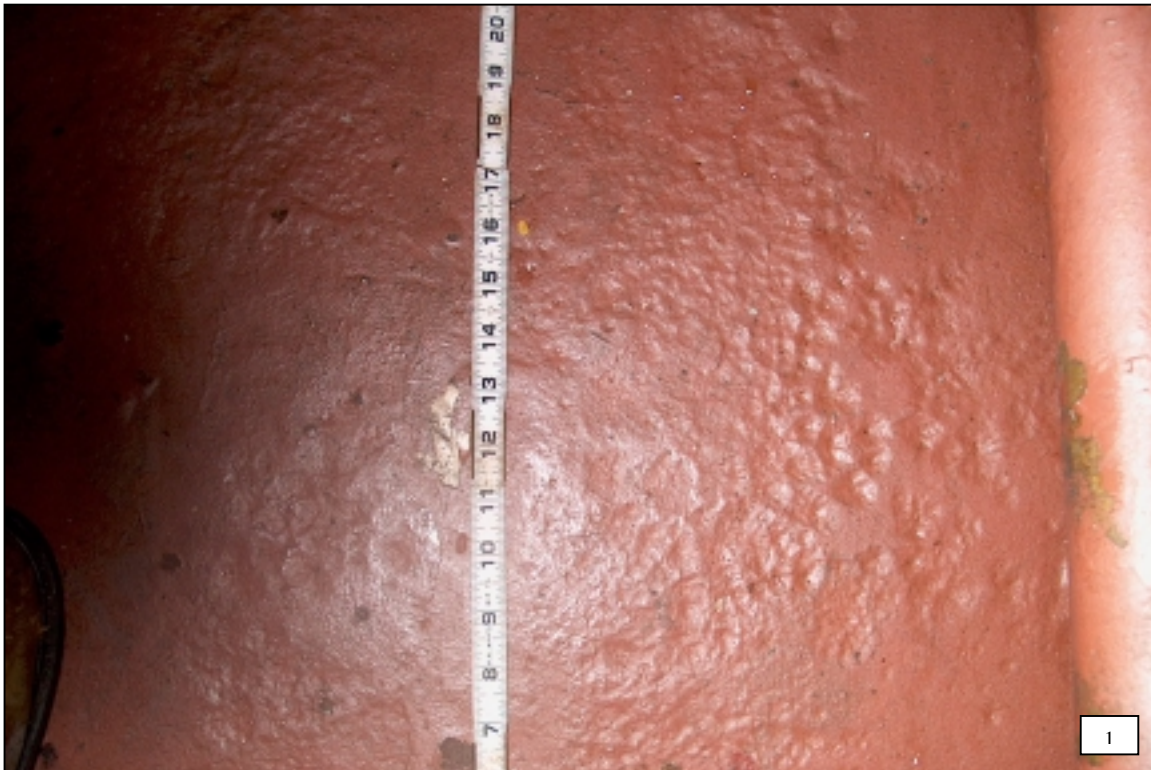
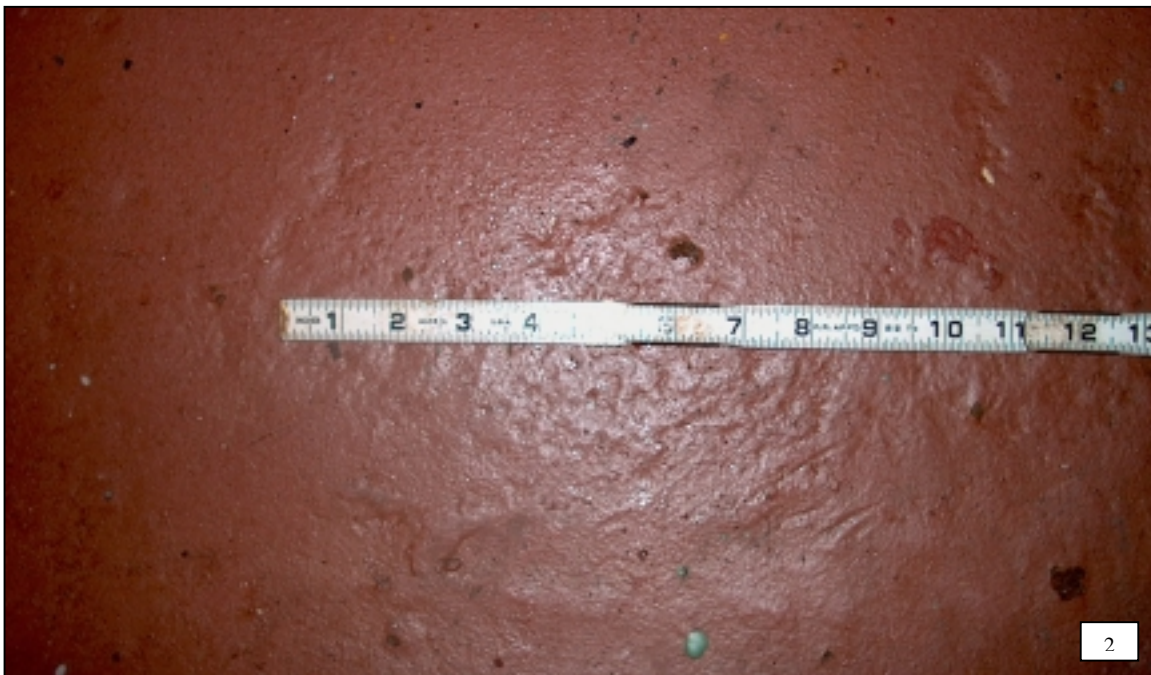
USS GETTYSBURG (CG 64)
MAIN ENGINE ROOM NO. 2
(5-300-0-E)

SSPORT C221 POC: J. BRUCKNER (757) 396-4001 EXT 2130 , TPOC: F. LaROCK QED											
CSMP SUMMARY: DEEP PITTING AND TORCH CUTS							TEST# MRC 1102/1				
ROOT CAUSE/AMPLIFICATION: H1							STEP# 1,2,3,4 & 5				
SYSTEM LEVEL IMPACT: NONE											
PART NO.		NOMENCLATURE			QTY		NSN		COST		
1											
2											
3											
4											
5											
6											
FIRST CONTACT KOLP		RATE HT1		SECOND CONTACT DANIELS			RATE HT2		PHONE		
ASSESSOR / ACT / TECH ID# F. LaROCK/ A. WRIGHT QED SYSTEMS INC.					TD	TL		LOGISTICIAN		TSP

AREA OF DEEP PITTING ON TANK TOP (6-300-2-F) UNDER SHAFT BETWEEN FRAMES 300 – 308 PORT SIDE

SAFETY HAZARD: 1. SERIOUS - CORRECT AS SOON AS POSSIBLE 2. SERIOUS - SUSPENSION OF EQUIPMENT/SYSTEM/SPACE REQUIRED 3. SERIOUS - WAIVER OF EQUIPMENT/SYSTEM 4. SAFETY ITEM - MINOR 5. COMBUSTIBLE MATERIAL				1. MAINTENANCE ACTION COMPLETED: PARTS DRAWN FROM SUPPLY 2. MAINTENANCE ACTION COMPLETED: REQUIRED PARTS NOT DRAWN FROM SUPPLY 3. MAINTENANCE ACTION COMPLETED: NO PARTS REQUIRED 4. CANCELLED - DEFERRAL WILL BE REMOVED FROM CSMP 5. MAINTENANCE ACTION COMPLETED: 3-M CAPABILITY UTILIZED 6. NONE OF THE ABOVE, DESCRIBE IN REMARKS/DESCRIPTION SECTION				1. MANDATORY 2. ESSENTIAL 3. HIGHLY DESIRABLE 4. DESIRABLE			
DISCREPANCY DESCRIPTION: PER SEMAT I UNDERWATER HULL ASSESSMENT: IN COMPT (5-300-0-E) THE TANK TOP AREA UNDER THE SHAFT HAS DEEP PITTING AND TORCH CUTS. LOWEST U/T READING 0.185, DESIGN 0.427, MINIMUM 0.329.											
RECOMMENDED REPAIRS: CROP OUT AND REPLACE APPROX 12 SQ FT OF 0.427 PLATE FM 13 INCHES AFT OF BHD 300 TO 54 INCHES AFT BHD 300 AND 5 INCHES OUTBD TO PORT OF MAIN LUBE OIL STRAINER FOUNDATION TO 31 INCHES OUTBD. CLEAN AND GAS FREE FUEL TANK (6-300-2-F), PRESERVE AND PAINT FINISH COAT TERRA COTTA.

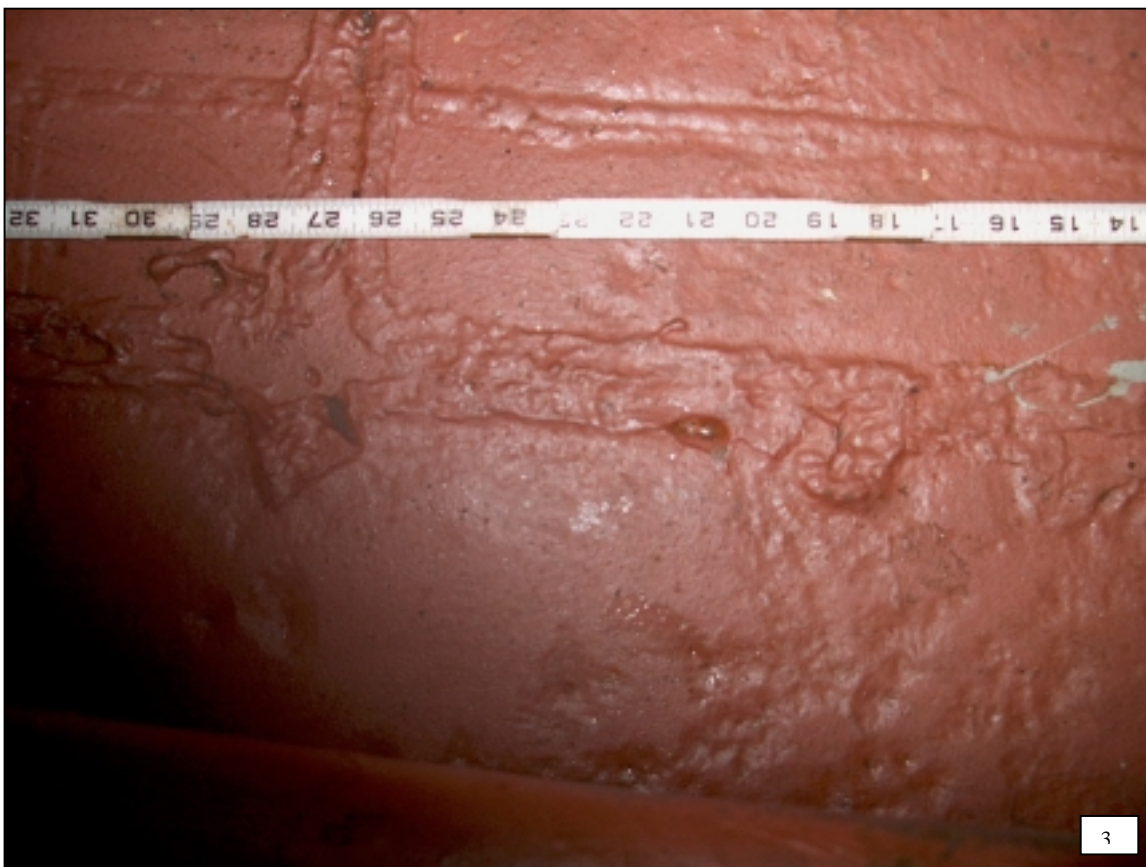
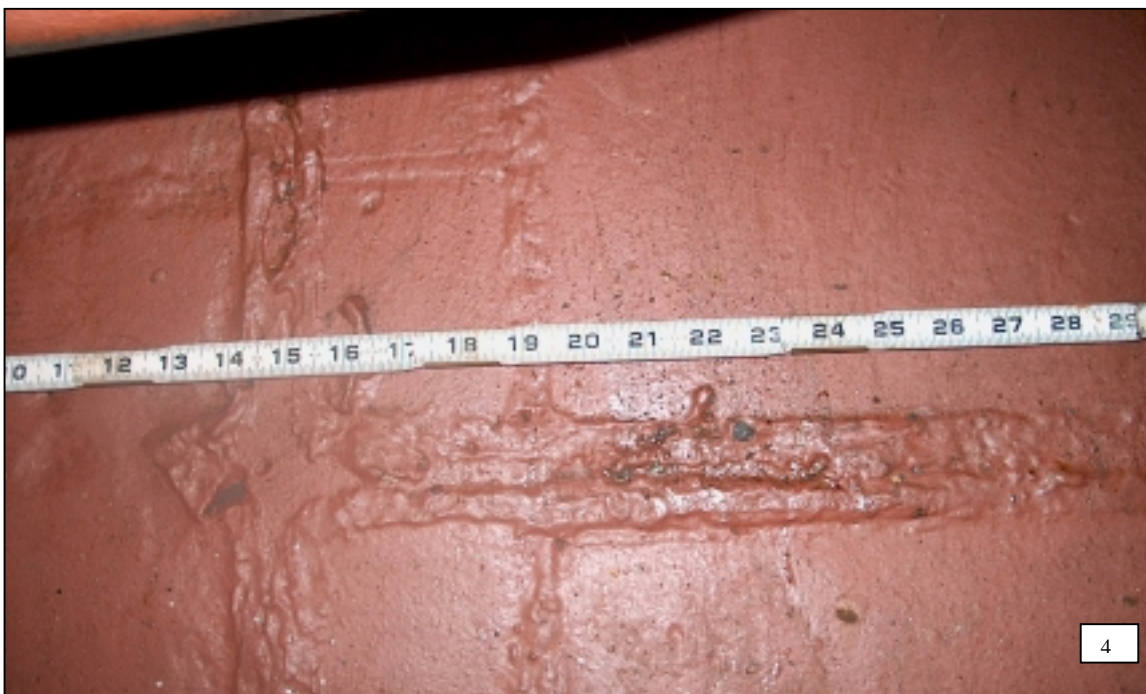
USS GETTYSBURG (CG 64)
MAIN ENGINE ROOM NO. 2
(5-300-0-E)

TANK TOP AREA UNDER THE SHAFT HAS DEEP PITTING AND TORCH CUTS

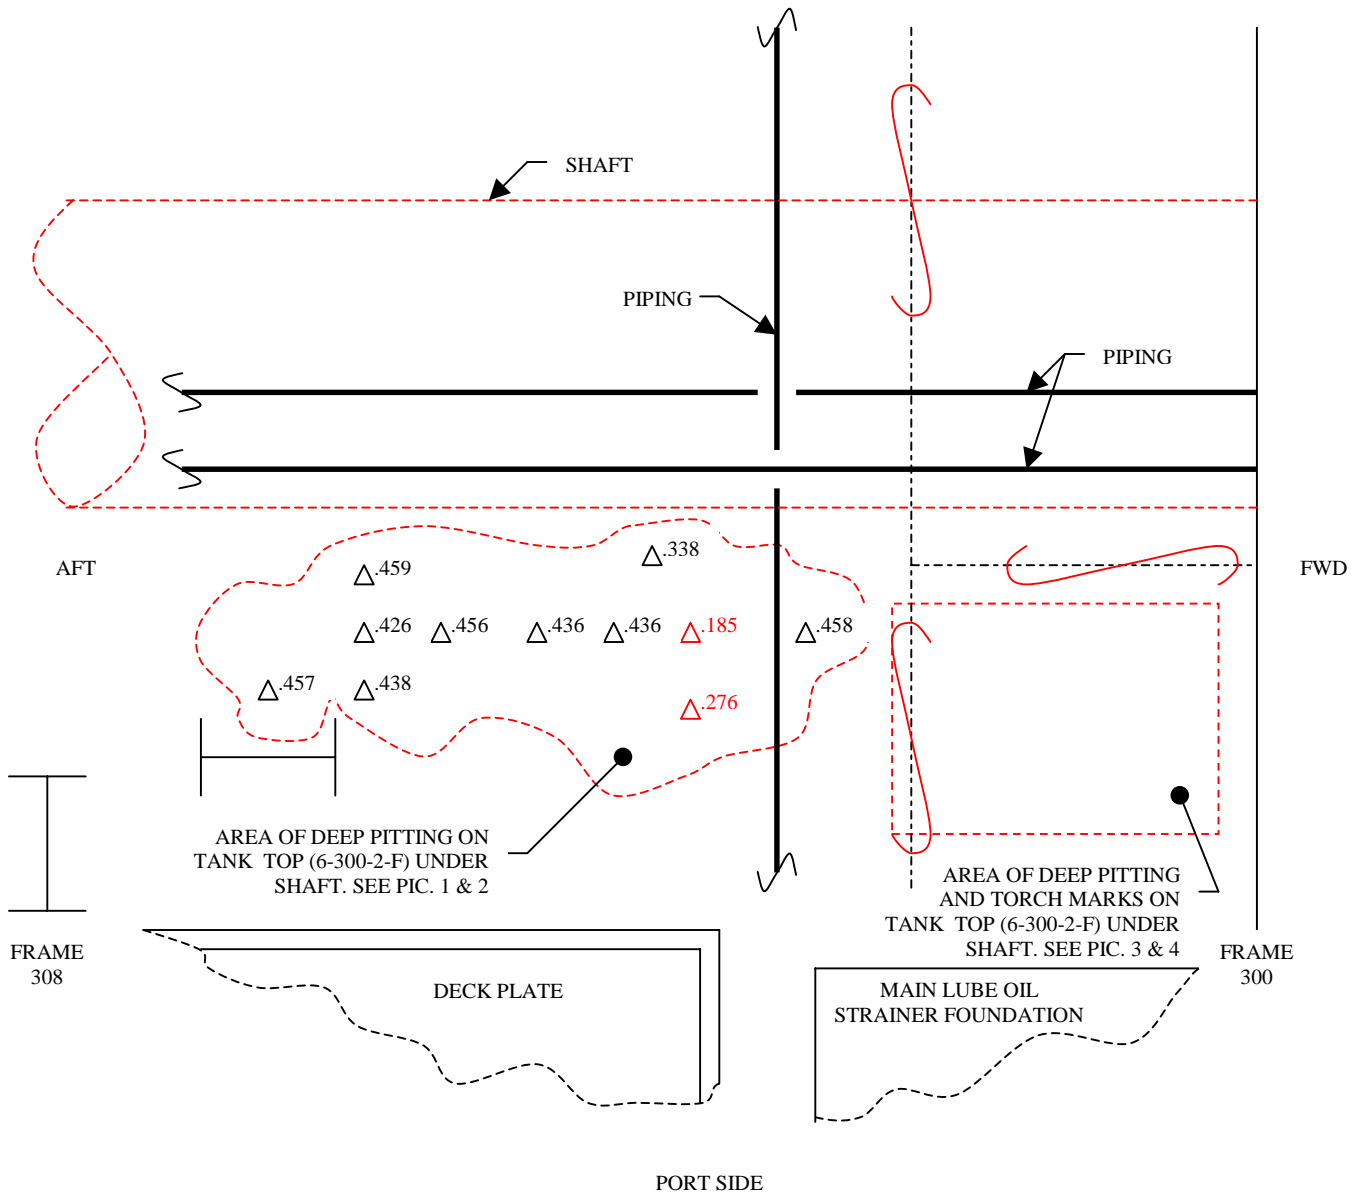
USS GETTYSBURG (CG 64)
MAIN ENGINE ROOM NO. 2
(5-300-0-E)

DESIGN	0.427
MINIMUM	0.329

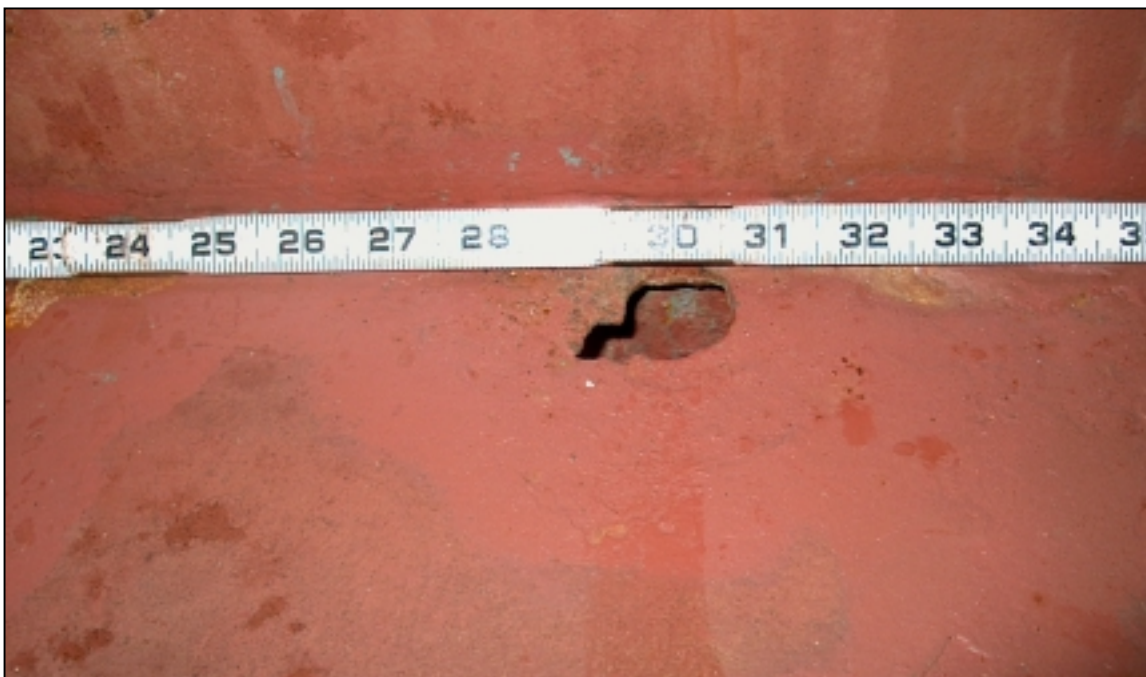
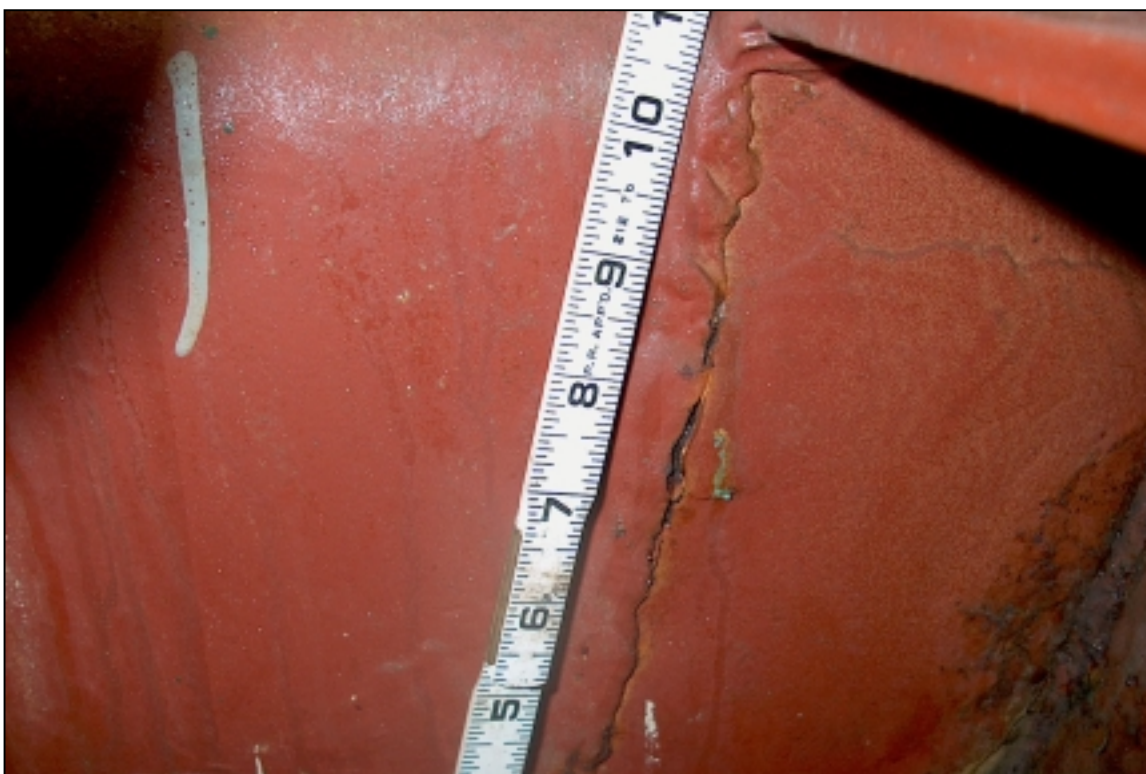
USS GETTYSBURG (CG 64)
MAIN ENGINE ROOM NO. 2
(5-300-0-E)

DISCREPANCY DESCRIPTION: PER SEMAT I UNDERWATER HULL ASSESSMENT: IN COMPT (5-300-0-E) PORT SIDE MID LEVEL FRAMES					
308 – 316. SUPPORT FOUNDATION HAS A CRACKED WELD (GEN NO. 2 SW STR)					
RECOMMENDED REPAIRS: VEE OUT AND REWELD APPROX 12 INCHES OF CRACKED WELD. PRIME AND PRESERVE FINISH COAT WHITE.					
SSPORT C221 POC: J. BRUCKNER (757) 396-4001 EXT 2130 , TPOC: F. LaROCK QED					
CSMP SUMMARY: SUPPORT FOUNDATION WELD CRACKED.				TEST# MRC 1102/1	
ROOT CAUSE/AMPLIFICATION: H1				STEP# 1,2,3,4 & 5	
SYSTEM LEVEL IMPACT: NONE					
PART NO.	NOMENCLATURE		QTY	NSN	COST
1					
2					
3					
4					
5					
6					
FIRST CONTACT KOLP	RATE HT1	SECOND CONTACT DANIELS	RATE HT2	PHONE	
ASSESSOR / ACT / TECH ID# F. LaROCK/ A. WRIGHT QED SYSTEMS INC.			TD	TL	LOGISTICIAN
					TSP

FOUNDATION BRACKET FOR GEN NO. 2 STRAINER BETWEEN FRAMES 308 – 316 HAS A CRACKED WELD

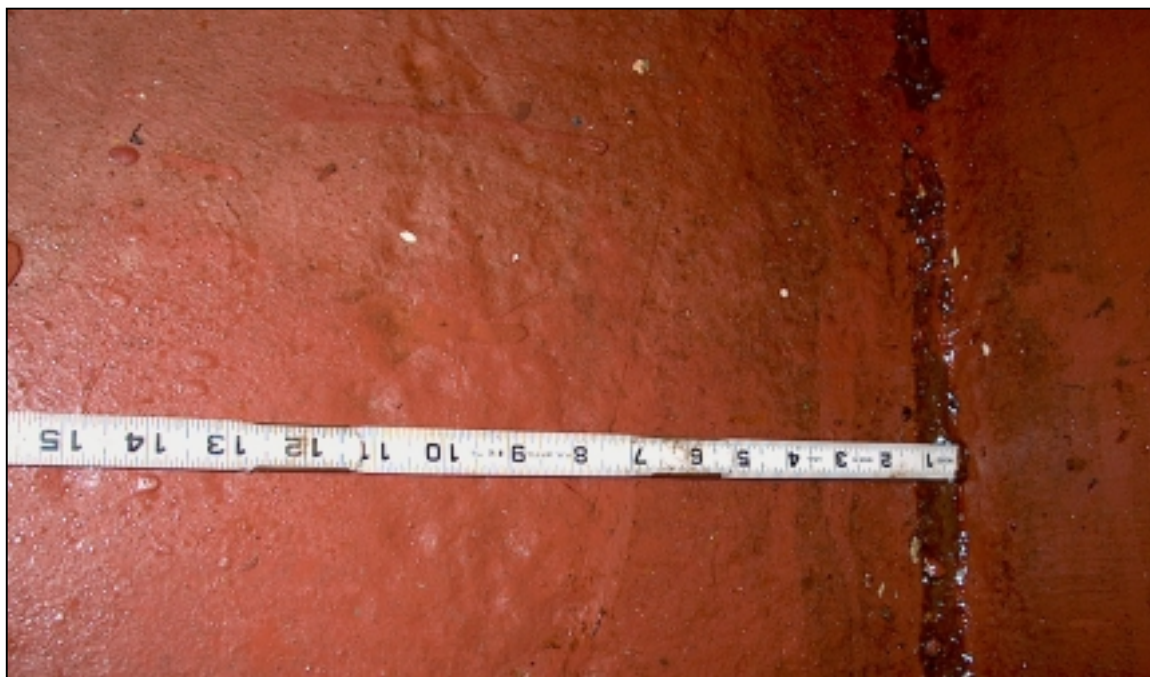
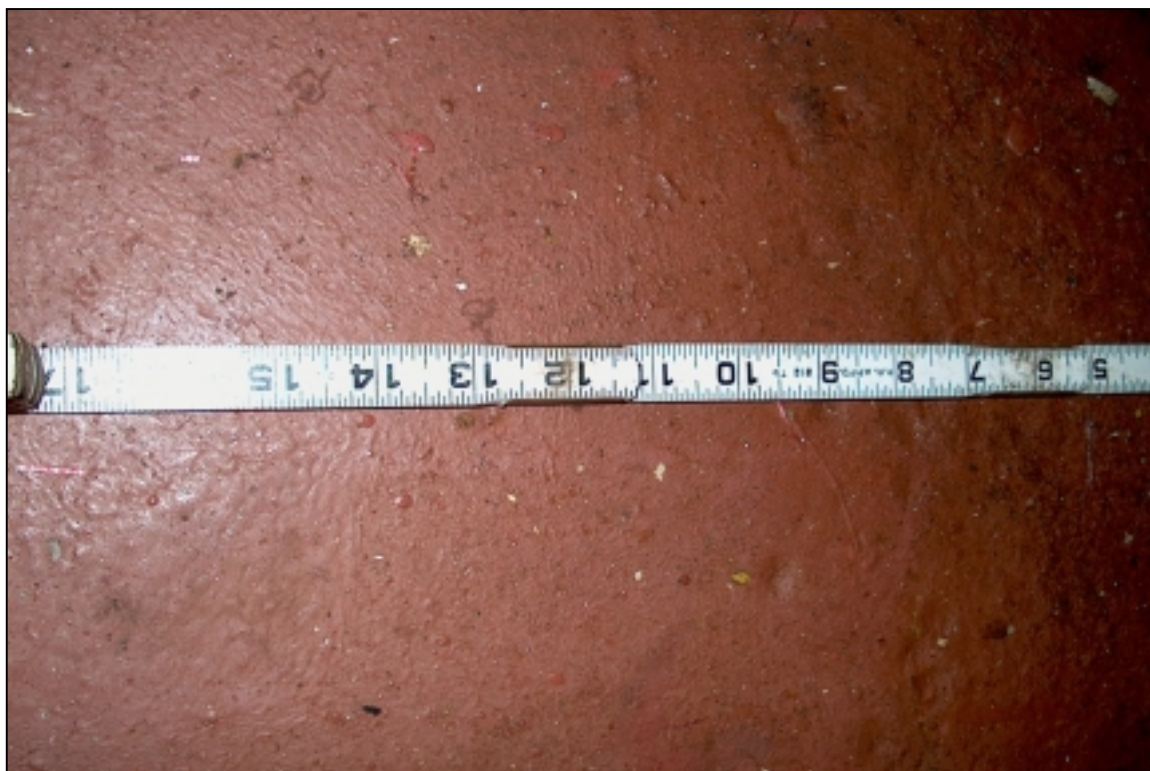
USS GETTYSBURG (CG 64)
MAIN ENGINE ROOM NO. 1
(5-174-0-E)

DISCREPANCY DESCRIPTION: PER SEMAT I UNDERWATER HULL ASSESSMENT: IN COMPT (5-174-0-E) IN THE AFT LOWER LEVEL					
(CONDENSATE CORNER) THE MARGIN PLATE HAS MANY PITTED AREAS. THE DEEPEST PIT WAS 0.313, DESIGN 0.500 MIN 0.375					
RECOMMENDED REPAIRS: CROP OUT AND REPLACE LOWER 18" OF MARGIN PLATE AN AREA OF APPROX 12 SQ FT (1.5 FT X 8 FT OF 0.500 PLATE, PRIME AND PRESERVE FINISH COAT TERRA COTTA. FUEL TANK 6-174-1-F WILL REQUIRE CLEANING AND GAS FREE.					
SSPORT C221 POC: J. BRUCKNER (757) 396-4001 EXT 2130 , TPOC: F. LaROCK QED					
CSMP SUMMARY: MARGIN PLATE PITTED				TEST# MRC 1102/1	
ROOT CAUSE/AMPLIFICATION: H1				STEP# 1,2,3,4 & 5	
SYSTEM LEVEL IMPACT: NONE					
PART NO.	NOMENCLATURE		QTY	NSN	COST
1					
2					
3					
4					
5					
6					
FIRST CONTACT KOLP	RATE HT1	SECOND CONTACT DANIELS	RATE HT2	PHONE	
ASSESSOR / ACT / TECH ID# F. LaROCK/ A. WRIGHT QED SYSTEMS INC.			TD	TL	LOGISTICIAN
					TSP

AREA OF SCATTERED DEEP PITTING WITH RULER LAYED OUT WITH 1" AT BOTTOM

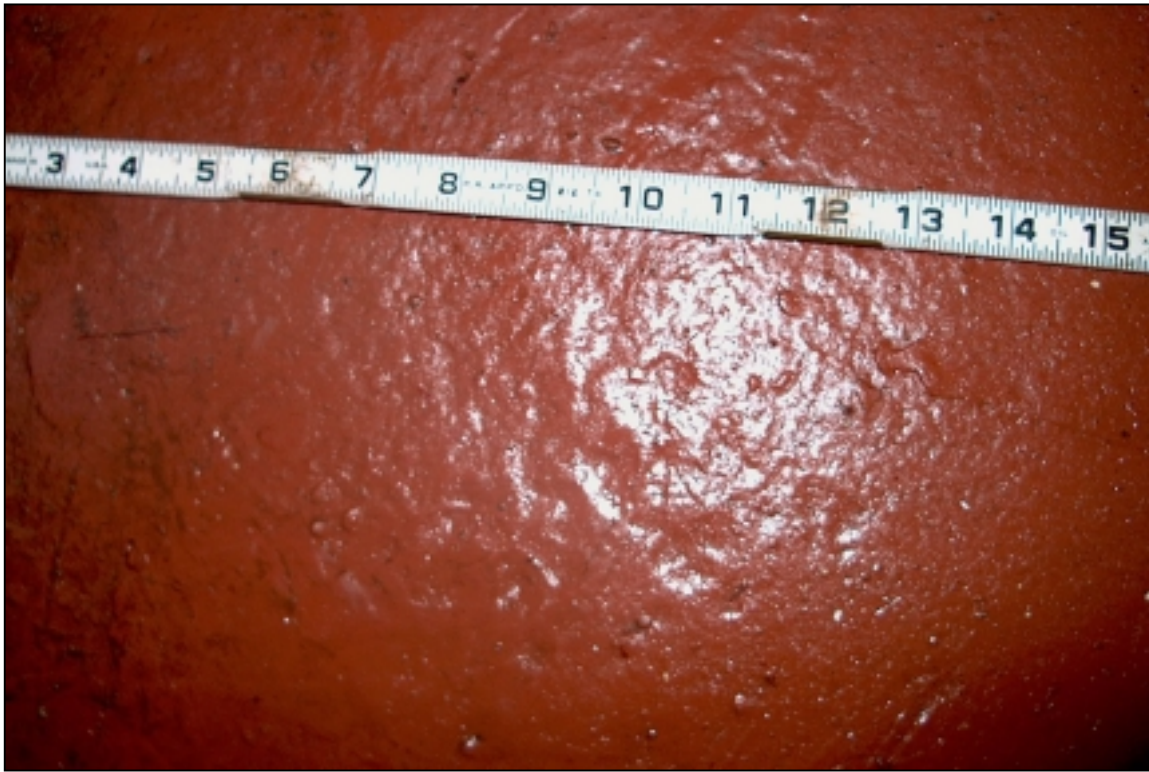
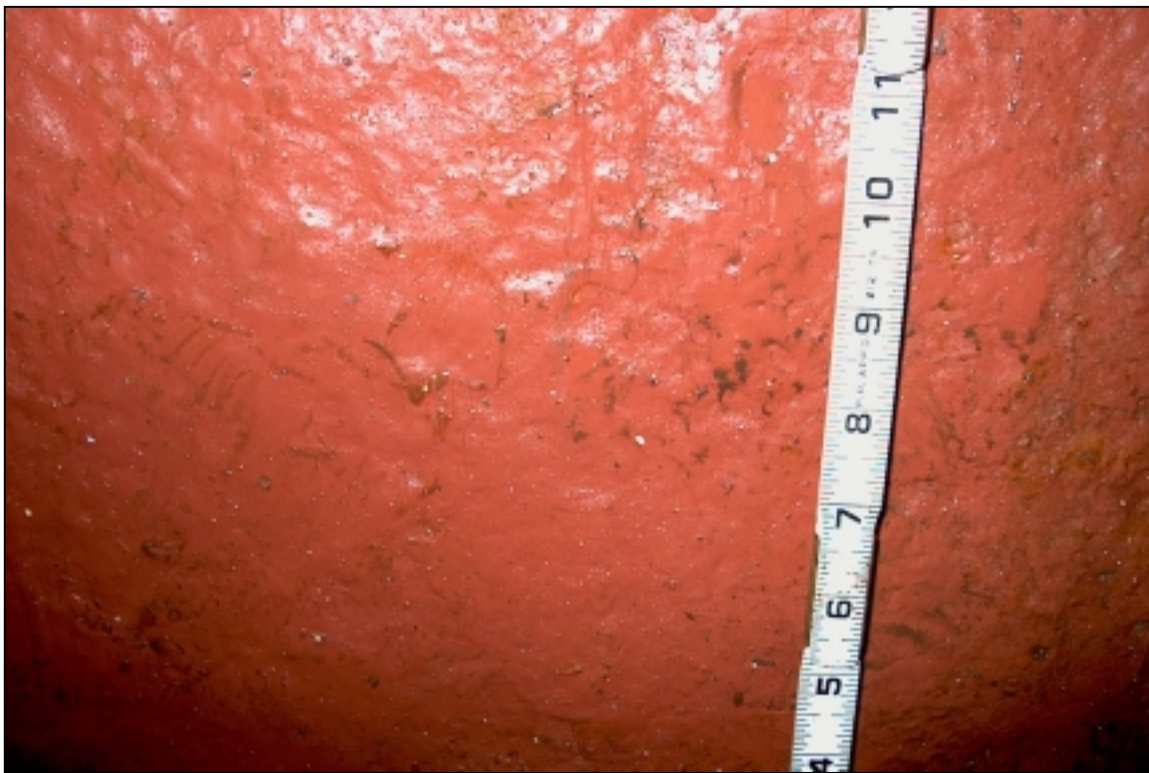
USS GETTYSBURG (CG 64)
MAIN ENGINE ROOM NO. 1
(5-174-0-E)

AREA OF SCATTERED DEEP PITTING WITH RULER LAYED OUT WITH 1" AT BOTTOM

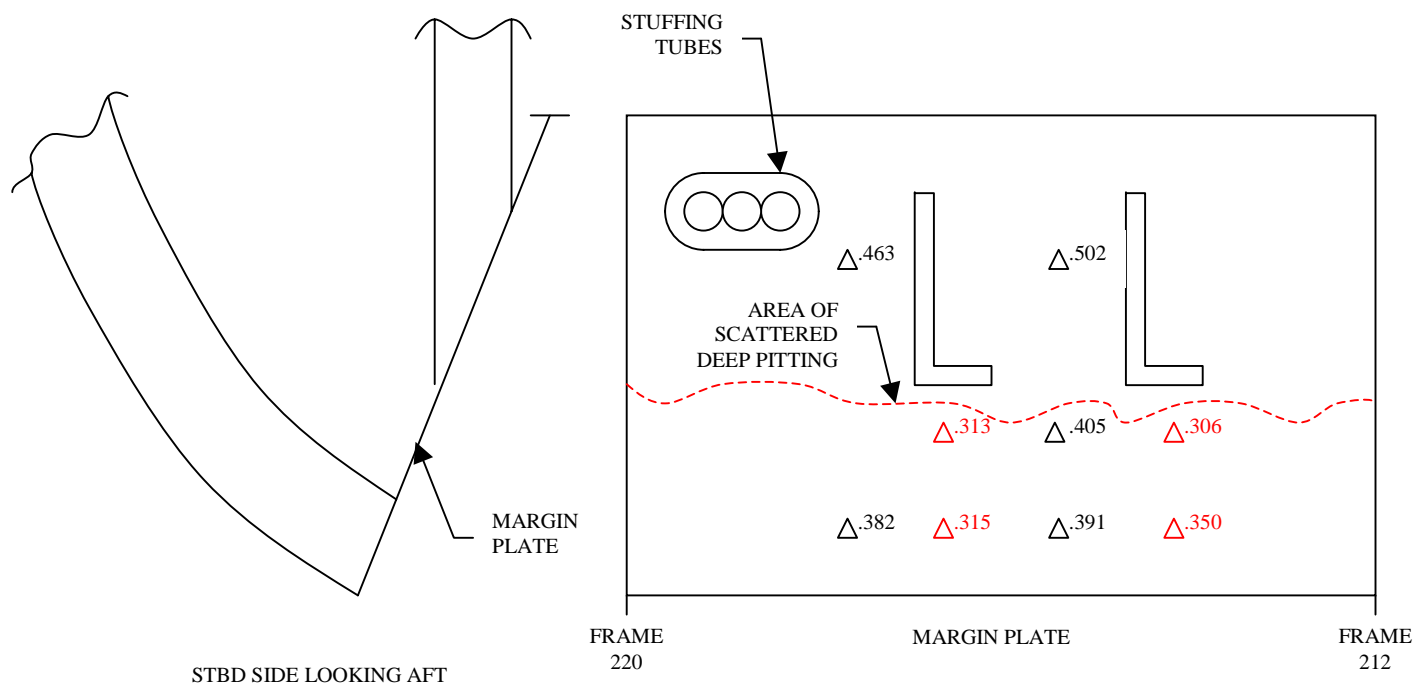
USS GETTYSBURG (CG 64)
MAIN ENGINE ROOM NO. 1
(5-174-0-E)

DESIGN	0.500
MINIMUM	0.375

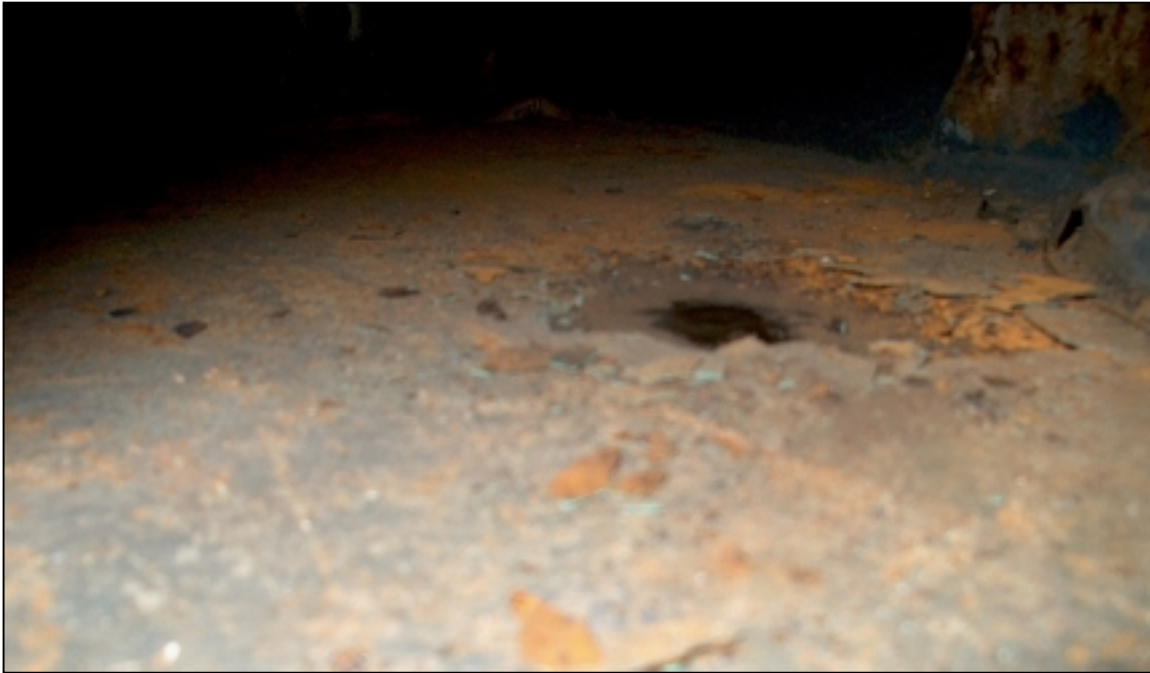
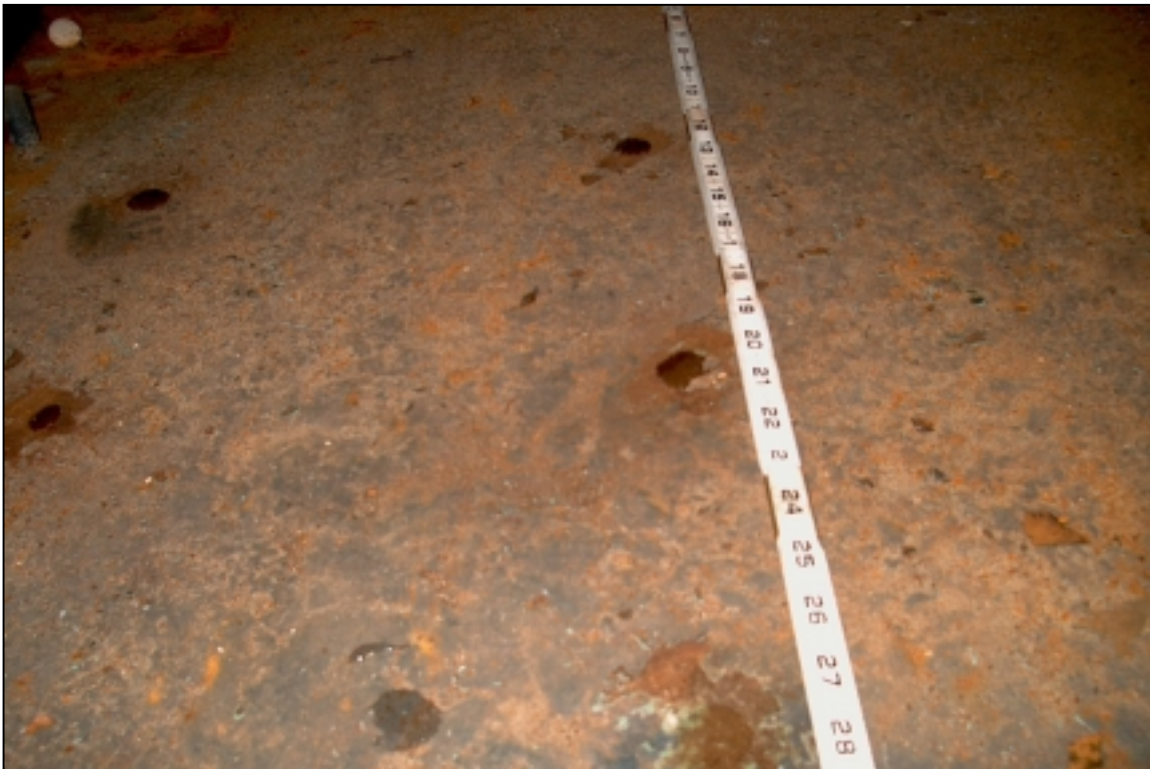
USS GETTYSBURG (CG 64)
BOSN STRM
(4-78-1-A)

SSPORT C221 POC: J. BRUCKNER (757) 396-4001 EXT 2130 , TPOC: F. LaROCK QED							
CSMP SUMMARY: COATING SYSTEM BREAKDOWN					TEST# MRC 1102/1		
ROOT CAUSE/AMPLIFICATION: H1					STEP# 1,2,3,4 & 5		
SYSTEM LEVEL IMPACT: NONE							
PART NO.	NOMENCLATURE			QTY	NSN	COST	
1							
2							
3							
4							
5							
6							
FIRST CONTACT KOLP		RATE HT1	SECOND CONTACT DANIELS		RATE HT2	PHONE	
ASSESSOR / ACT / TECH ID# F. LaROCK/ A. WRIGHT QED SYSTEMS INC.				TD	TL	LOGISTICIAN	TSP

AREA HAS COATING SYSTEM BREAKDOWN UNDER STORAGE RACKS

SAFETY HAZARD: 1. SERIOUS - CORRECT AS SOON AS POSSIBLE 2. SERIOUS - SUSPENSION OF EQUIPMENT/SYSTEM/SPACE REQUIRED 3. SERIOUS - WAIVER OF EQUIPMENT/SYSTEM 4. SAFETY ITEM - MINOR 5. COMBUSTIBLE MATERIAL			1. MAINTENANCE ACTION COMPLETED: PARTS DRAWN FROM SUPPLY 2. MAINTENANCE ACTION COMPLETED: REQUIRED PARTS NOT DRAWN FROM SUPPLY 3. MAINTENANCE ACTION COMPLETED: NO PARTS REQUIRED 4. CANCELLED - DEFERRAL WILL BE REMOVED FROM CSMP 5. MAINTENANCE ACTION COMPLETED: 3-M CAPABILITY UTILIZED 6. NONE OF THE ABOVE, DESCRIBE IN REMARKS/DESCRIPTION SECTION			1. MANDATORY 2. ESSENTIAL 3. HIGHLY DESIRABLE 4. DESIRABLE	
DISCREPANCY DESCRIPTION: PER SEMAT I UNDERWATER HULL ASSESSMENT: IN COMPT (4-78-1-A) THE DECK/ OVHD OF SUMP IS HEAVILY SCALED. U/T READING WERE SATISFACTORY, AVERAGE 0.240 DESIGN 0.250 MIN 0.187.							
RECOMMENDED REPAIRS: POWER TOOL CLEAN, PRIME AND PAINT FINISH COAT DARK DECK GRAY.

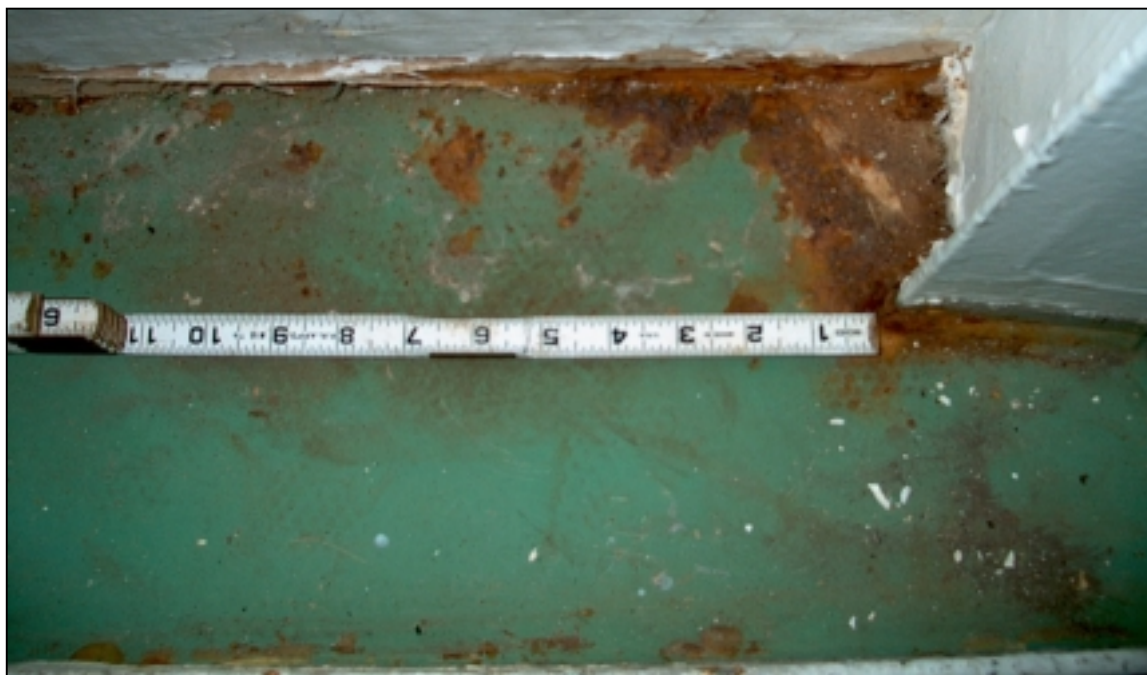
USS GETTYSBURG (CG-64)
DOME EQUIPMENT ROOM
(4-58-0-Q)

DISCREPANCY DESCRIPTION: PER SEMAT I UNDERWATER HULL ASSESSMENT: IN COMPT (4-58-0-Q) THERE ARE THREE AREAS					
WHERE INSULATION IS MISSING AND SLIGHT CORROSION EXISTS ON STRINGERS U/T READING OF 0.229 AND 0.232 DESIGN 0.227					
MIN 0.150					
RECOMMENDED REPAIRS:					
POWER TOOL CLEAN THE STRINGERS, PRIME THE SURFACES AND REPLACE APPROX 16 SQ FT OF ONE INCH INSULATION, SEAL THE JOINTS					
AND PAINT TO MATCH SURROUNDING AREAS.					
SSPORT C221 POC: J. BRUCKNER (757) 396-4001 EXT 2130 , TPOC: F. LaROCK QED					
CSMP SUMMARY: STIFFENERS SCALED/ INSULATION MISSING				TEST# MRC 1102/1	
ROOT CAUSE/AMPLIFICATION: H1				STEP# 1,2,3,4 & 5	
SYSTEM LEVEL IMPACT: NONE					
PART NO.	NOMEMCLATURE		QTY	NSN	COST
1					
2					
3					
4					
5					
6					
FIRST CONTACT KOLP	RATE HT1	SECOND CONTACT DANIELS	RATE HT2	PHONE	
ASSESSOR / ACT / TECH ID# F. LaROCK/ A. WRIGHT QED SYSTEMS INC.			TD	LOGISTICIAN	TSP

AREA SHOWS TYPICAL RUST, SCALE AND 6 SQ FT OF ONE INCH INSULATION MISSING BETWEEN FRAMES 64-70 FOR THE 1ST STRINGER UP FROM THE DECK ON STBD SIDE.

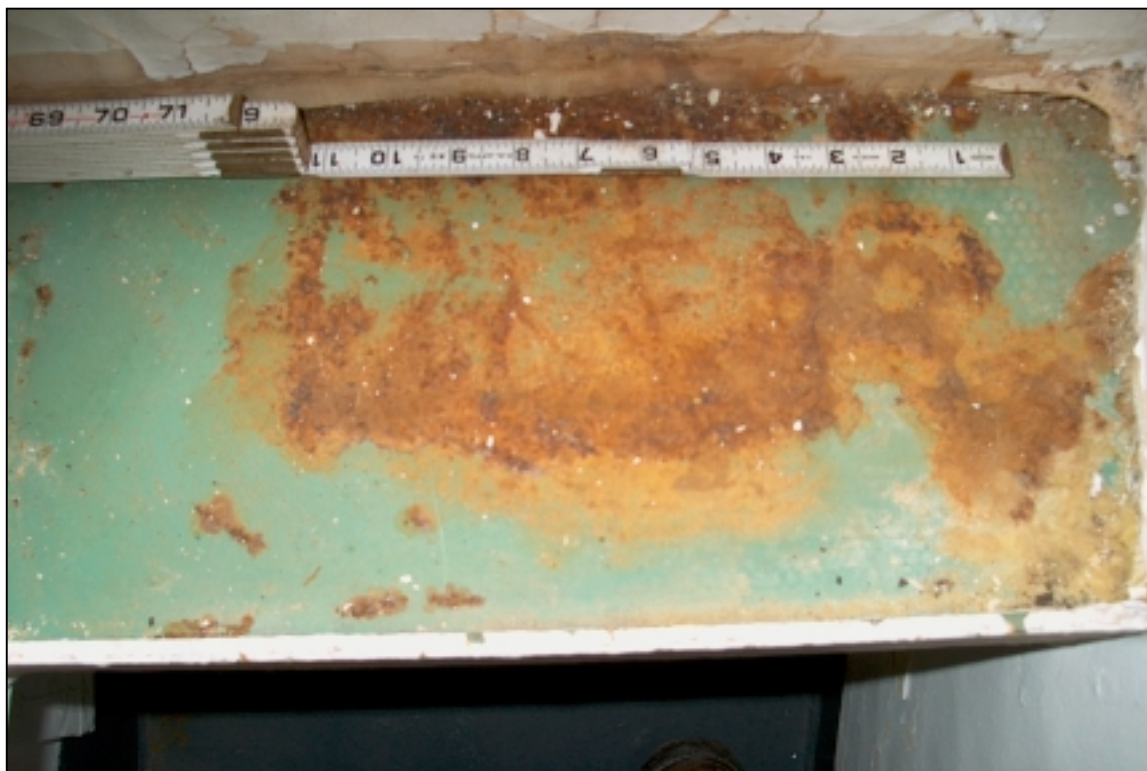
AREA SHOWS TYPICAL RUST, SCALE AND 2 SQ FT OF ONE INCH INSULATION MISSING BETWEEN FRAMES 76-78 FOR BOTH 1ST AND 2ND STRINGERS UP FROM THE DECK ON STBD SIDE.

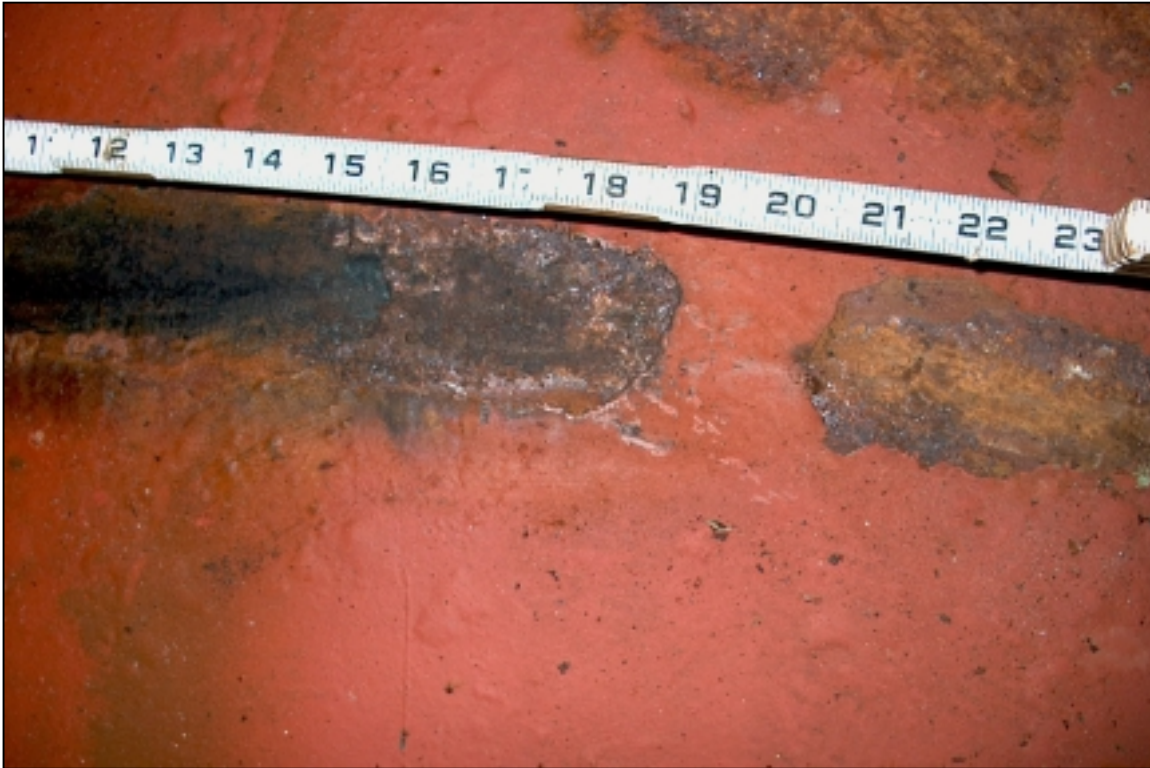
USS GETTYSBURG (CG-64)
LANDING FORCE STRM
(3-426-2-A)

DISCREPANCY DESCRIPTION: PER SEMAT I UNDERWATER HULL ASSESSMENT: THE MARGIN PLATE AREA IN COMPT (3-426-2-A) HAS LOOSE FLAKING AND SCALE FROM SALT WATER INTRUSION FROM COMPT (3-440-2-A). LOWEST U/T READING WAS 0.294, DESIGN 0.375 AND THE MIN: 0.281, APPROX 60 SQ FT OF SURFACE AREA.					
RECOMMENDED REPAIRS: POWER TOOL CLEAN MARGIN PLATE AND SHELL AREA FROM FRAME 426 TO FRAME 440 PRIME AND PAINT, FINISH COAT TERRA COTTA.					
SSPORT C221 POC: J. BRUCKNER (757) 396-4001 EXT 2130 , TPOC: F. LaROCK QED					
CSMP SUMMARY: COATING SYSTEM BREAKDOWN				TEST# MRC 1102/1	
ROOT CAUSE/AMPLIFICATION: H1				STEP# 1,2,3,4 & 5	
SYSTEM LEVEL IMPACT: NONE					
PART NO.	NOMENCLATURE		QTY	NSN	COST
1					
2					
3					
4					
5					
6					
FIRST CONTACT KOLP	RATE HT1	SECOND CONTACT DANIELS		RATE HT2	PHONE
ASSESSOR / ACT / TECH ID# F. LaROCK/ A. WRIGHT QED SYSTEMS INC.			TD	TL	LOGISTICIAN
					TSP

AREA SHOWS LOOSE AND FLAKING SCALE

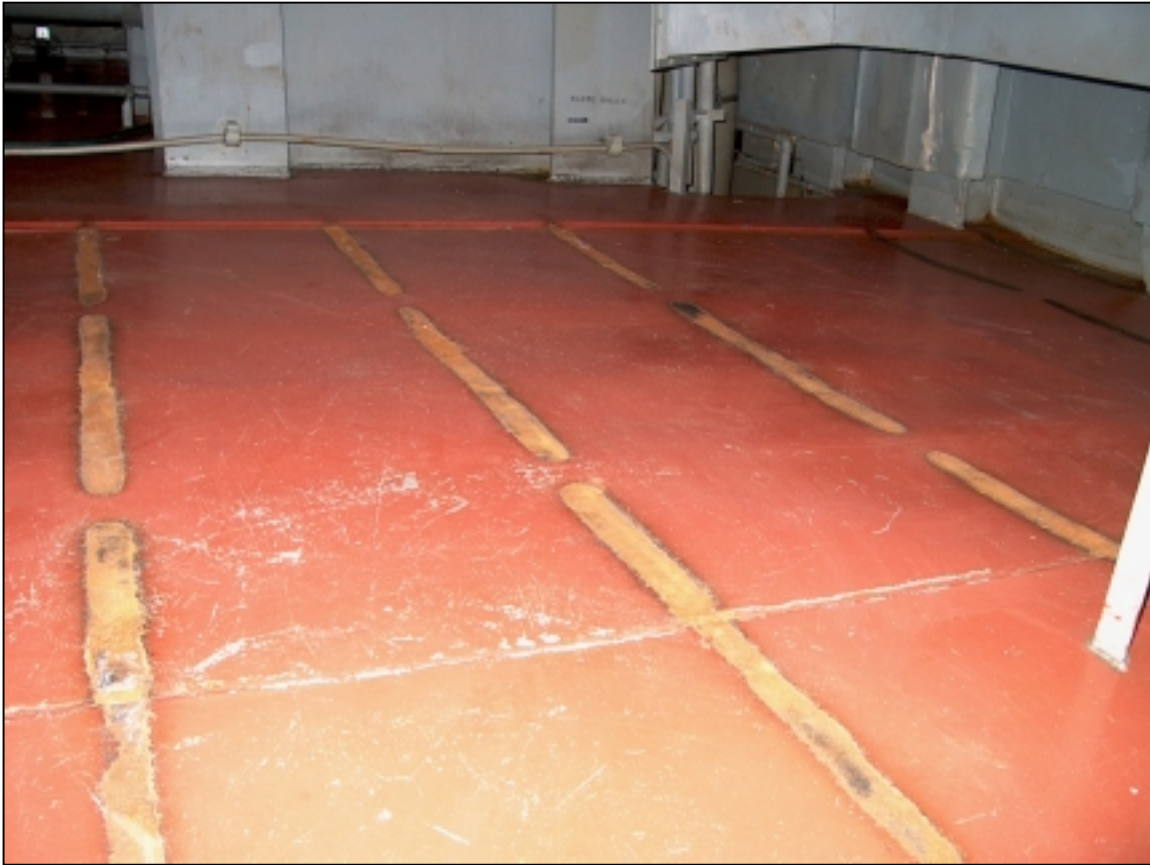
USS GETTYSBURG (CG 64)
MISSILE MAGAZINE STRM
(3-94-0-M)

DISCREPANCY DESCRIPTION: PER SEMAT I UNDERWATER HULL ASSESSMENT: IN COMPT (3-94-0-M) MISSILE MAGAZINE, THE DECK					
THAT IS ALSO THE TANK TOP FOR FUEL TANKS (6-94-1-F) AND (6-94-2-F) HAS WELD BURNED PAINT ABOVE WHERE THE TANK TOP/ DECK					
WAS STRENGTHENED AND WORK NOT PROPERLY COMPLETED.					
RECOMMENDED REPAIRS:					
POWER TOOL CLEAN BURNED AREAS, PRIME AND PAINT THE TANK TOP/ DECK AND FINISH COAT TERRA COTTA					
SSPORT C221 POC: J. BRUCKNER (757) 396-4001 EXT 2130 , TPOC: F. LaROCK QED					
CSMP SUMMARY: PAINT BURNED DUE TO WELDING				TEST# MRC 1102/1	
ROOT CAUSE/AMPLIFICATION: H1				STEP# 1,2,3,4 & 5	
SYSTEM LEVEL IMPACT: NONE					
PART NO.	NOMENCLATURE		QTY	NSN	COST
1					
2					
3					
4					
5					
6					
FIRST CONTACT KOLP	RATE HT1	SECOND CONTACT DANIELS		RATE HT2	PHONE
ASSESSOR / ACT / TECH ID# F. LaROCK/ A. WRIGHT QED SYSTEMS INC.			TD	TL	LOGISTICIAN
					TSP

BURNED PAINT IN WELD REPAIR ON TANK TOP (6-94-1-F) AND (6-94-2-F)
